LAKE CLASSIFICATION SHORT REPORT ON JORDAN LAKE, ADAMS COUNTY, WI

Presented by Reesa Evans, Lake Specialist
Adams County Land & Water Conservation Department
P.O. Box 287, Friendship, WI 53934

OCTOBER 2007

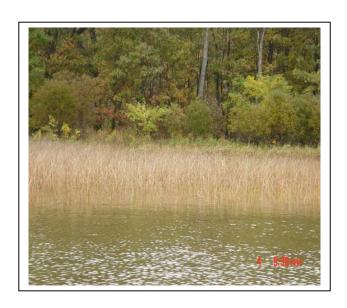
The photo below shows one of the wetlands along Jordan Lake's shore. There are several wetlands at or near its shore.

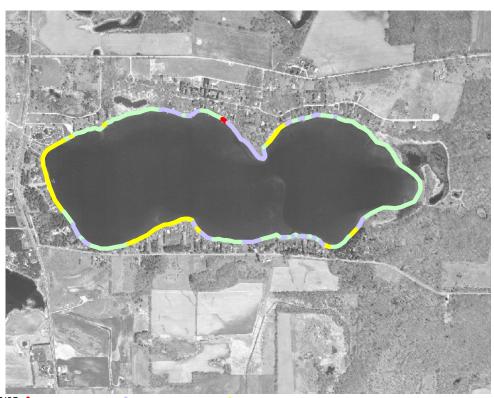
Jordan Lake has a total shoreline 2.8 miles (14,784 feet). Most of the shoreline is in residential or commercial housing. Several buildings are located less than 70 feet from the high water mark. Some of the banks are steep and sandy; some are flatter. Marsh areas are located along some of the shore. There is an undeveloped section of shore on the east end of the lake.

Only about 28% of Jordan Lake's shoreline is vegetated with native plants (grasses, forbs, shrubs, trees). Over 42% of the shore was covered with traditional mowed lawn.

Shoreline on Jordan Lake

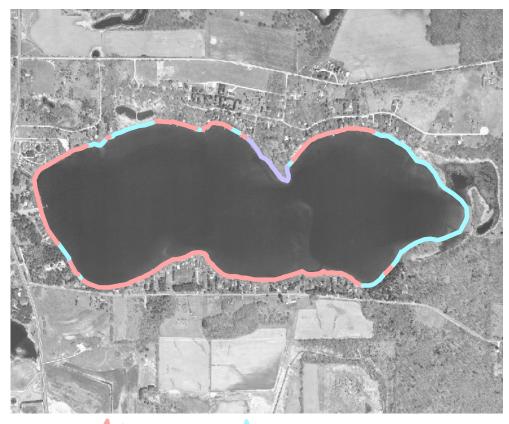
Jordan Lake Buffers

A 2004 shore survey showed that only about 1/4 of the shore had an "adequate buffer." An "adequate buffer" is a native vegetation strip at least 35 feet landward from the shore. Most of the "inadequate" buffer areas were those with hard structure, mowed lawns and/or insufficient native vegetation at the shoreline to cover 35 feet landward from the water line.

Inadequate Buffers

Adequate Buffers

- The sites that currently have inadequate buffers should have adequate buffers installed. Buffers are the least expensive way the filter pollutants and prevent or decrease their addition to the lake

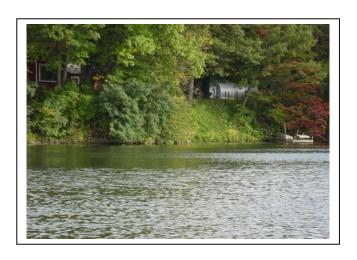
Example of Adequate Buffer

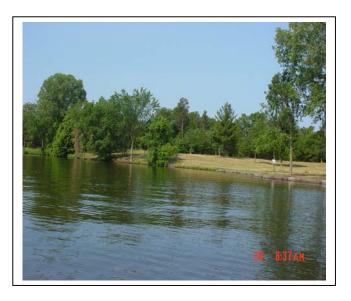
Example of Inadequate Buffer

- Shores with inadequate buffers need to restore the buffers to an adequate condition to provide winter habitat for these weevils, as well to assist in maintaining water quality.

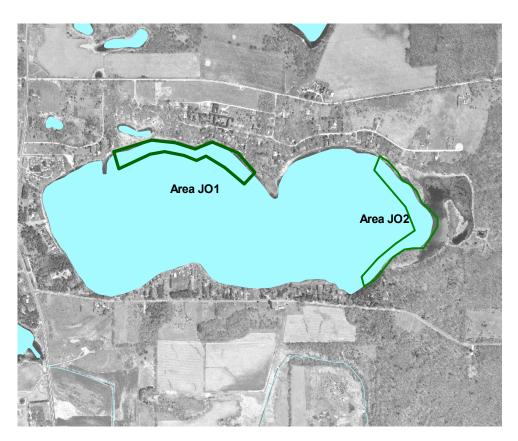
Critical Habitat Areas--Jordan

Two areas on Jordan Lake were determined to be appropriate for critical habitat designation. JO1 extends along approximately 2600 feet of the north shoreline of the Lake, up to the ordinary high water mark. JO2 extends along approximately 1800 feet of the far east shore and is, at the point, unaltered and undeveloped.

- Maintain current habitat for fish and wildlife.
- Leave fallen trees along shoreline & in water.
- Seasonal protection of spawning habitat.
- Maintain the wildlife corridor.
- Protection emergent vegetation.
- No removal of aquatic vegetation in the littoral zone, except for the view/access corridor (30' of 100', or 30% of shores less than 100') or for WDNR-approved projects.
- Seasonal control of exotics. Hand removal of exotics in these areas, if possible.
- No bank grading or grading of adjacent land. Shore restoration should be bioengineering, if possible.
- Maintain aquatic vegetation in undisturbed condition for wildlife habitat, fish use and water quality protection.
- Make these areas no-wake areas to encourage low disturbance.
