LAKE CLASSIFICATION SHORT REPORT ON JORDAN LAKE, ADAMS COUNTY, WI

Presented by Reesa Evans, Lake Specialist
Adams County Land & Water Conservation Department
P.O. Box 287, Friendship, WI 53934

OCTOBER 2007

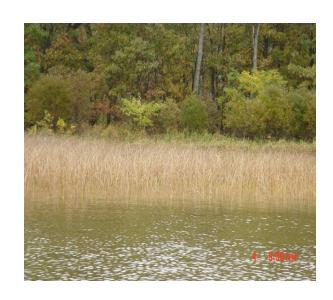
The photo below shows one of the wetlands along Jordan Lake's shore. There are several wetlands at or near its shore.

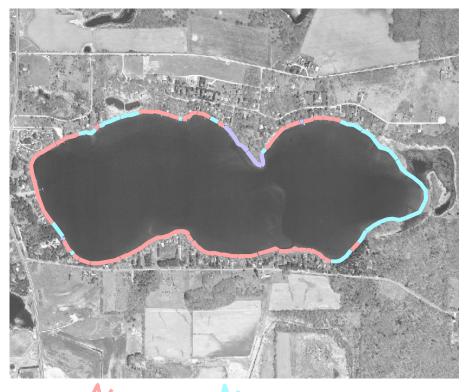
Jordan Lake Buffers

A 2004 shore survey showed that only about 1/4 of the shore had an "adequate buffer." An "adequate buffer" is a native vegetation strip at least 35 feet landward from the shore. Most of the "inadequate" buffer areas were those with hard structure, mowed lawns and/or insufficient native vegetation at the shoreline to cover 35 feet landward from the water line.

- The sites that currently have inadequate buffers should have adequate buffers installed. Buffers are the least expensive way the filter pollutants and prevent or decrease their addition to the lake.

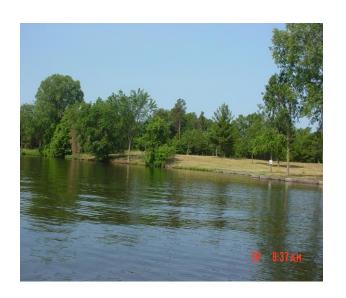
Example of Adequate Buffer

Shoreland buffers are an important part of lake protection and restoration. These buffers are simply a wide border of native plants, grasses, shrubs and trees that filter and trap soil & similar sediments, fertilizer, grass clippings, stormwater runoff and other potential pollutants, keeping them out of the lake. A 1990 study by the Wisconsin Department of Natural Resources of Wisconsin shorelines revealed that a buffer of native vegetation traps 5 to 18 times more volume of potential pollutants than does a developed, traditional lawn or hard-armored shore. The filtering process and bank stabilization that buffers provide help improve a lake's water quality, including water clarity.

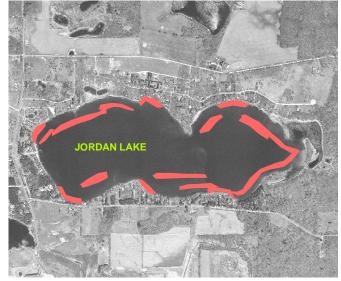
Exotic Aquatic Vegetation Found In Jordan Lake 2006

Important to maintaining such a quality, diverse aquatic plant community is an integrated aquatic plant management plant that controls the invasive plants in the lake. The most prevalent invasive exotic in Jordan Lake is currently *Myriophyllum spicatum* (Eurasian watermilfoil), which currently has a patchy pattern of occurrence around the lake. Other invasive plants found were *Potamogeton crispus* (Curly-Leaf Pondweed) and *Phalaris arundinacea* (Reed Canary Grass). The latter two are less common at Jordan Lake.

- The Jordan Lake District should maintain exotic species signs at the boat landings and contact DNR if the signs are missing or damaged.
- The Jordan Lake District should continue monitoring and control of Eurasian Watermilfoil maintain the most effective methods and modify if necessary. The Lake District should investigate ways to increase treatment effectiveness in the deeper water. Residents may need to hand-pull scattered plants.

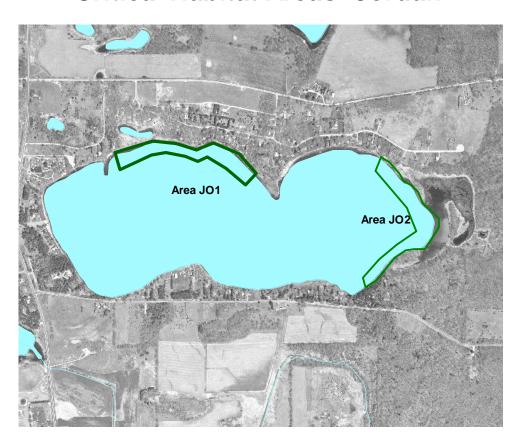
Critical Habitat Areas--Jordan

Two areas on Jordan Lake were determined to be appropriate for critical habitat designation. JO1 extends along approximately 2600 feet of the north shoreline of the Lake, up to the ordinary high water mark. JO2 extends along approximately 1800 feet of the far east shore and is, at the point, unaltered and undeveloped.

- Maintain current habitat for fish and wildlife.
- Leave fallen trees along shoreline & in water.
- Seasonal protection of spawning habitat.
- Maintain the wildlife corridor.
- Protection emergent vegetation.
- No removal of aquatic vegetation in the littoral zone, except for the view/access corridor (30' of 100', or 30% of shores less than 100') or for WDNR-approved projects.
- Seasonal control of exotics. Hand removal of exotics in these areas, if possible.
- No bank grading or grading of adjacent land. Shore restoration should be bioengineering, if possible.
- Maintain aquatic vegetation in undisturbed condition for wildlife habitat, fish use and water quality protection.
- Make these areas no-wake areas to encourage low disturbance.
