MEMORANDUM

TO: The Jordan Lake Rehabilitation and Protection District

SUBJECT: Results of the October 20, 2014 milfoil mapping survey

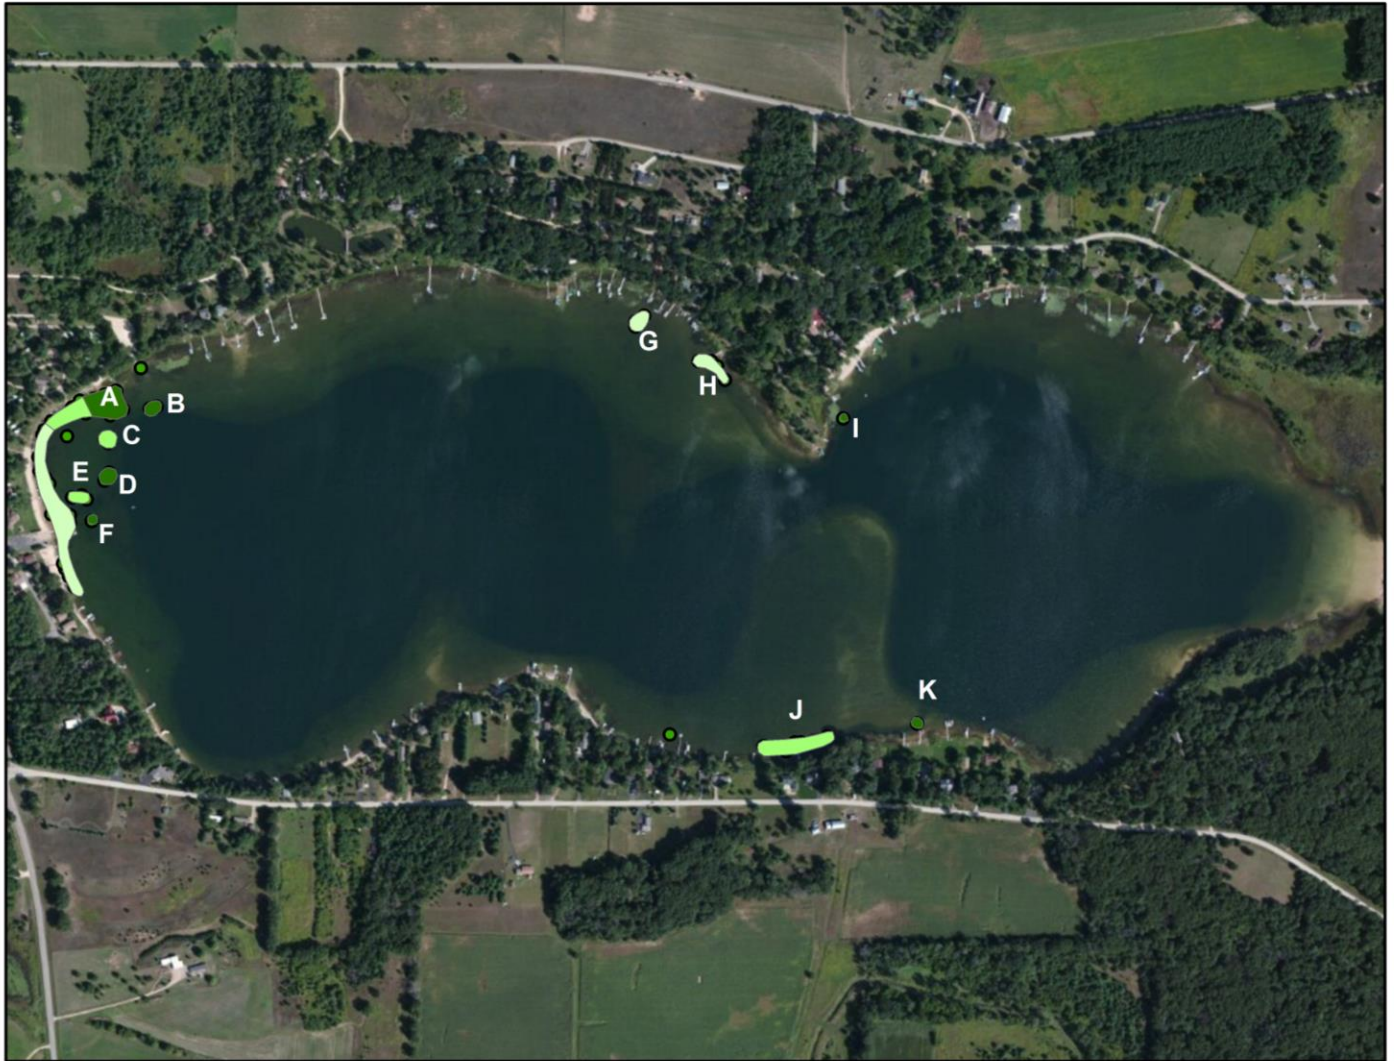
A total of 14 locations of Eurasian/hybrid watermilfoil covering an area of 3.4 acres were found during the October 2014 survey. Eleven of these locations were discreet beds while three contained individual plants or small groups of plants (**Figure 1**). Bed density ranged from highly scattered to moderately dense. Beds ranged in depth from 3.5 to 9.0 feet. Most locations were found in areas that had previously been chemically treated. In general, the acreage and densities of the Eurasian/hybrid watermilfoil beds throughout Jordan Lake during the fall 2014 survey had declined since the fall 2013 survey.

Figure 1. Distribution of Eurasian/hybrid watermilfoil in Jordan Lake, Adams County, WI during the October 20, 2014 survey.

Traditionally, annual chemical treatments have been the tool of choice for managing Eurasian/hybrid watermilfoil in Jordan Lake. In the spring of 2015, a chemical treatment could again be utilized. The lone milfoil bed should be targeted using Navigate[®]. The application rate for milfoil ranges from 2.0 to 4.0 ppm. For small, isolated beds, the maximum labeled rate of 4.0 ppm (56.8 lbs/acre-ft) is recommended. The higher concentration requires less contact time to be effective.

Chemical treatments can provide seasonal relief from EWM, but may not provide long-term control at these small scales. Often these beds are found in the same locations from year to year. These treatments also serve to prevent or slow the further spread of EWM throughout the lake. While this approach rarely leads to eradication, these treatments can serve as a means to prevent wide-spread expansion of EWM. **Table 1** provides a breakdown of estimated treatment costs for 2015.
