JLRPD

Mechanical Removal of Aquatic Invasive Species on Jordan Lake, Adams County.

SEPTEMBER 2009

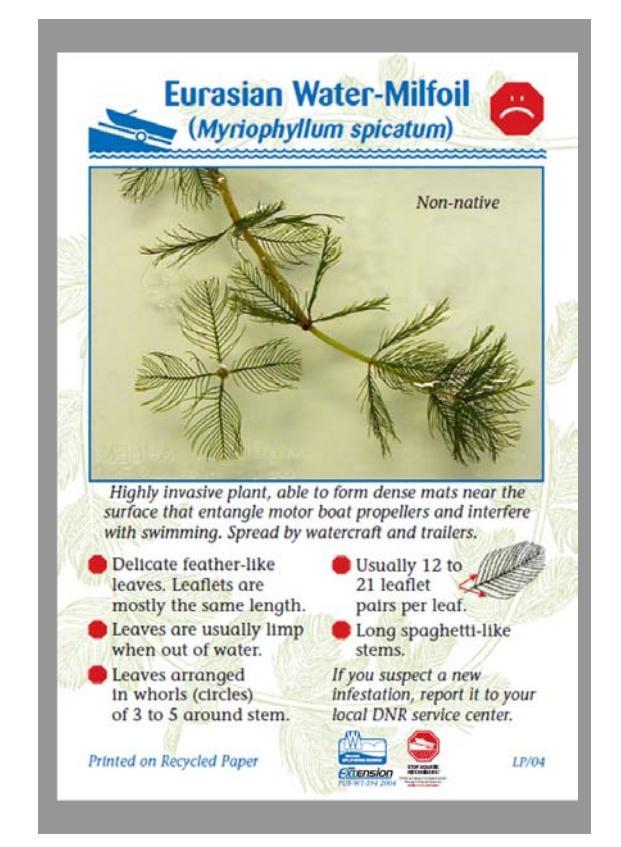
Eurasian Water Milfoil (EWM)

EWM is a very prolific plant that doesn't spread much by seeds. It spreads mostly by fragments that can grow roots and start new plants. It may also grow shoots and runners that run along the lake bottom.

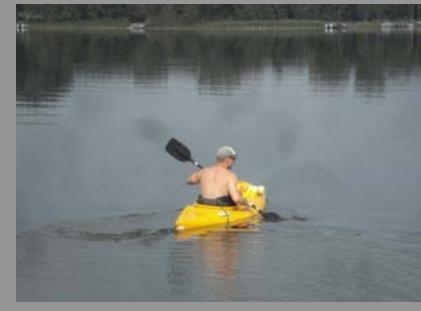
We conducted visual surveys on kayak to identify potential handpulling areas.

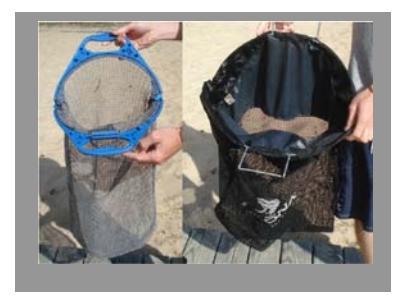
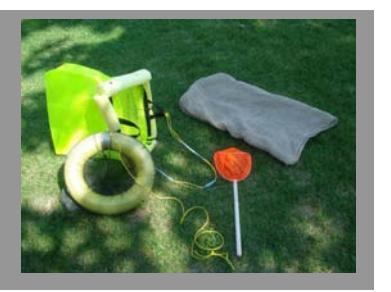
Two floating containers that were used in shallow harvesting (left), a burlap sack that was also used to help strain out water from plant mass (right), and a minnow net that could be used by a person in a kayak to collect floating fragments (bottom right) are all examples of the tools we used.

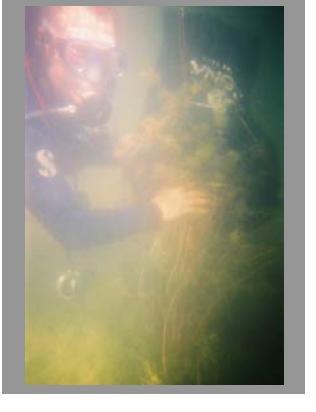
The top part of the plant is placed into a collection bag

Since EWM can propagate by fragmentation, it is best to place the plant in the collection bag before proceeding to pull to reduce lost fragments. It is also helpful to do this slowly to prevent fragmentation of the fragile plant.

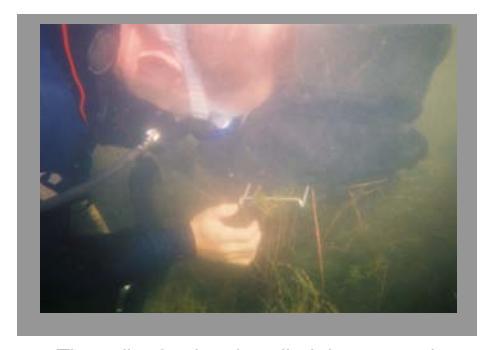
The collection bag is pulled down over the plant down to where the roots start

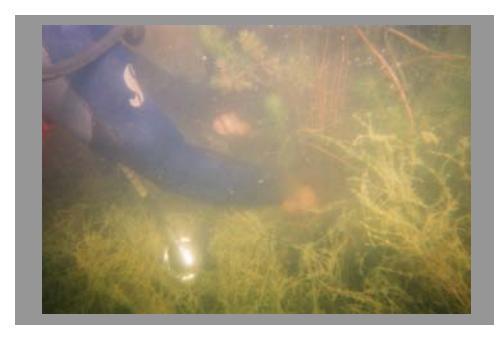
The removal of the root mass is essential for prevention of reoccurrence. Once the top part of the plant is placed in the collection bag, follow the stems down to the lake substrate and extract the root mass. It is best to this slowly, as fast movements increase the amount of sediment released into the water impacting visibility.

The root mass is removed by hand and shaken to remove excess sediment

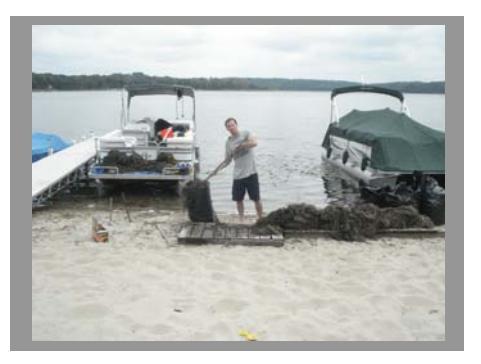
At the end of each day the harvested EWM was laid out to dry for at least a day before loading it into heavy duty garbage bags. This cut down on weight when having to transport the EWM for disposal

Plant material was laid out to dry before being placed into heavy duty plastic bags.

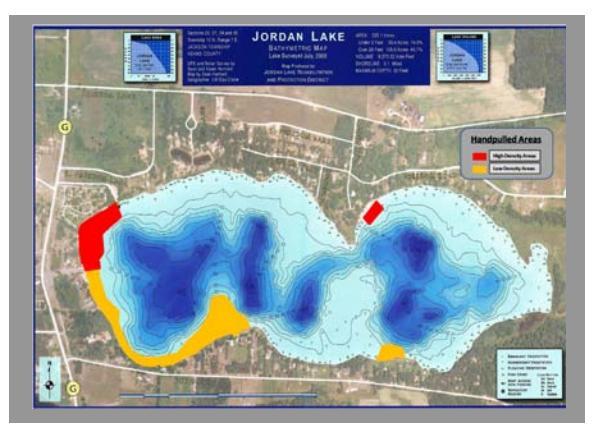
To our knowledge, handpulling has never been used as a method of control in Jordan Lake. Chemical treatment and weed cutting have been the only methods used. As a result, we conducted kayak and boat surveys in order to get an idea of the locations and densities of EWM. We decided to concentrate our efforts on two areas (see Lake Map below): one of low stem density (orange) and one of high stem density (red).

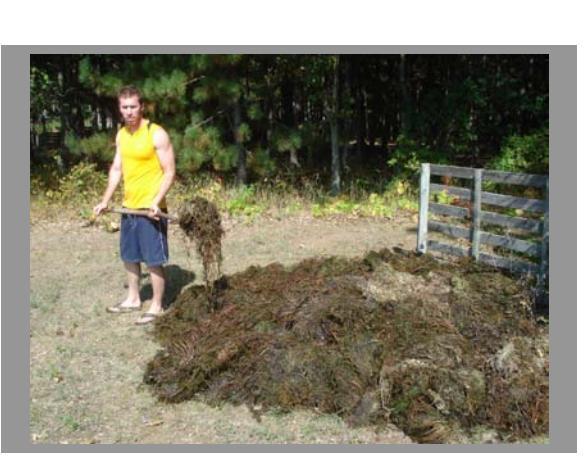
Hand Harvested EWM was taken to a local gardener to be used in compost.
